8th International Conference on Asian and Pacific Coasts (APAC 2015)

Beach erosion downcoast of Pengambengan fishing port in western part of Bali Island

Takaaki Uda^{a,*}, Shin Onaka^b, Masumi Serizawa^c^aPublic Works Research Center, 1-6-4 Taito, Taito, Tokyo 110-0016, Japan^bNippon-Koei Co., Ltd., 5-4 Kojimachi, Chiyoda, Tokyo 102-8539, Japan^cCoastal Engineering Laboratory Co., Ltd., 1-22-301 Wakaba, Shinjuku, Tokyo 160-0011, Japan

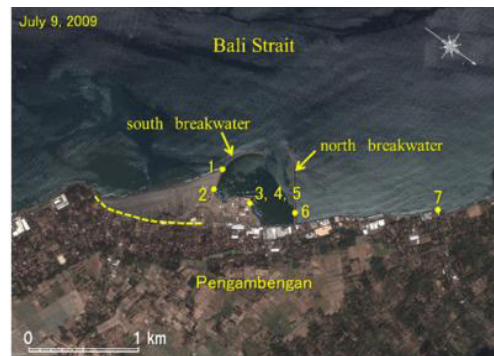
Fig. 2. Satellite image of Pengambengan fishing port taken on July 9, 2009.

Site observations were carried out on November 24, 2011 in rectangular area A, which includes Pengambengan fishing port, and area B, where the coastline orientation markedly changes, as shown in Fig. 1. Figure 2 shows the satellite image taken on July 9, 2009 and the location numbers of the site photographs taken in area A. The construction of Pengambengan fishing port started in 2000 (Uda et al., 2004). A semicircular breakwater was extended on the south side of the fishing port with an opening of 220 m length to the north breakwater, as shown in Fig. 2. The length of the south breakwater is 660 m. Because predominant waves are incident from the southeast

approximately parallel to the mean coastline in this area, northwestward longshore sand transport prevails, resulting in accretion south of the breakwater. In contrast, the beach has been eroded north of the fishing port, and the coastline was completely covered with the seawall. Although the shoreline connected to the south breakwater at site No. 1 on July 9, 2009, sand was transported westward along the south breakwater and deposited inside the fishing port, and a sand spit elongated to block the navigation channel, as shown in Fig. 3, up to May 12, 2011. This explains the disruption of northward longshore sand transport at this fishing port. Figure 4 shows the satellite image taken on May 30, 2014. A jetty was extended at the entrance of the fishing port to block the successive deposition of sand inside the port, and sand has already been deposited on the south side of the jetty.

Longshore sand transport at Pengambangan fishing port was estimated from the shoreline changes after the extension of the south breakwater in 2000. The previous shoreline before the extension of the south breakwater is approximately given by the broken line in Fig. 2, and the increase in foreshore area between 2000 and 2009 is $2.8 \times 10^5 \text{ m}^2$. The volumetric changes of the beach can be calculated by multiplying the increase in foreshore area by the characteristic height of beach changes, h , which is defined as a regression coefficient between the change in the cross-sectional area of the beach and the shoreline changes. Using the relation $h_c = h_R/0.31$ and $h = 1.3h_c$ among the berm height h_R , the depth of closure h_c and h proposed by Uda (1997), and given the berm height of 1.2 m measured upcoast of the south breakwater, h becomes 5.1 m. Now, the sand volume deposited upcoast of the breakwater and the annual rate are calculated to be $1.4 \times 10^5 \text{ m}^3$ and $1.6 \times 10^5 \text{ m}^3/\text{yr}$, respectively. Assuming that the entire longshore transport was blocked by the south breakwater, longshore sand transport is estimated to be $1.6 \times 10^5 \text{ m}^3/\text{yr}$. This transport rate has the same order of magnitude as $2.15 \times 10^5 \text{ m}^3/\text{yr}$ measured at Santa Barbara and is greater than the value of $3.7 \times 10^4 \text{ m}^3/\text{yr}$ evaluated at Oyashirazu fishing port.

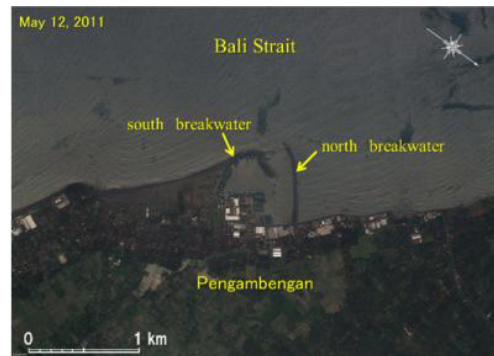
Fig. 3. Satellite image of Pengambengan fishing port taken on May 12, 2011.

Further north of Pengambengan fishing port, waves are obliquely incident at a large angle in the direction normal to the shoreline, because the predominant direction of incident waves is approximately parallel to the mean direction of the coastline. Therefore, the infinitesimal perturbation on the shoreline can develop to form sand spits with rhythmic forms owing to the shoreline instability, as described in previous papers (Zenkovich, 1967; Ashton and Murray, 2006; Serizawa et al., 2012). In particular, the coastline significantly protrudes 6.6 km northwest of the fishing port, and a sand bar of 2 km length extended northward parallel to the coastline from the tip of the protrusion, as shown in Fig. 5, and the tip of the sand bar approached a mere 128 m from the opposite shore on July 9, 2009. Because the tip of the slender sand bar did not connect to the opposite shore at this stage, sand supplied by northward longshore sand transport was used only for the elongation of the sand spit without sand supply to the downcoast, implying that the beach was eroded near the shoreline on the opposite shore. The second observation site is the eroded beach downcoast of this elongating sand bar. The location numbers of site photographs taken downcoast of the slender sand bar are shown in Fig. 5. The observation site is located on the concave shoreline north of the slender sand bar. Figure 6 shows the slender sand bar deformation up to May 30, 2014, and the sand bar elongated with the attachment of the tip to the opposite shore, whereas the sand bar was eroded upcoast and a discontinuous shoreline was formed with an opening of 590 m with the elongation of another sand spit in front of the river mouth. A sandy beach was recovered downcoast where it was once eroded.

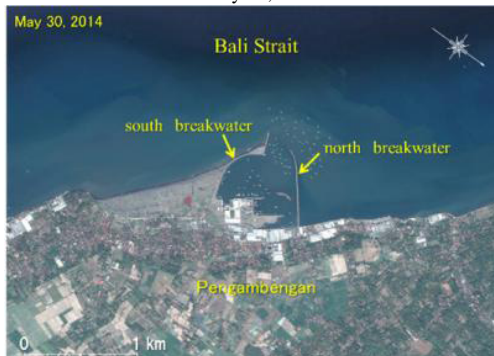
Fig. 4. Satellite image of Pengambengan fishing port taken on May 30, 2014.

At Pengambangan fishing port, a jetty had been extended at the tip of the south breakwater by May 30, 2014, as shown in Fig. 4, to block further sand deposition inside the port by a structural measure against sand deposition. However, sand was quickly deposited immediately south of the jetty owing to the blocking of the continuous longshore sand transport, suggesting further downcoast erosion. The past history clearly shows that soon after the sand deposition south of the jetty, sand will again be deposited inside the fishing port; a vicious cycle is occurring. If the construction of the breakwater will be continued in the same manner as in the present, it may lead the same situation as the eroded coast downcoast of Oyashirazu fishing port, where a large amount of expenditure was needed for the repair of the seawall. To avoid this situation, sand bypassing is a necessary measure, similarly to that at Santa

Barbara. Although Pengambengan fishing port is actively used as an unloading base of fishes, the cost of environmental protection will significantly increase in the long term, because sufficient measures have not been taken against beach erosion downcoast. The economic prosperity while leaving the outside economy poor will cause future problems. At a location 6.6 km northwest of the fishing port, downcoast erosion occurred with the elongation of a slender sand bar. Wooden fences have been used as a measure against erosion, even though they seemed to be ineffective. However, sand supply is possible after the tip of the sand bar connects with the opposite shore, which indeed had happened by May 30, 2014, as shown in Fig. 6. Taking this situation into account, it is better to maintain the beach by adopting the present simple measures, such as using wooden fences along with beach nourishment, if necessary, instead of constructing permanent structures against erosion.

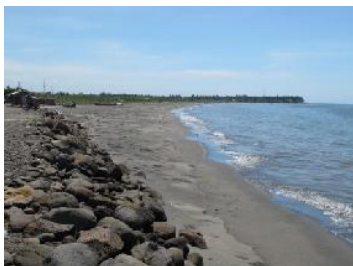
Photo 1 shows the shoreline upcoast of the fishing port extending to the headland, as shown in Fig. 2, taken from the top of the south breakwater, while facing the southeast. A sandy beach, composed of fine and medium-size sand with a gentle slope, continuously extended to the headland south of the fishing port. The berm height was approximately 1.2 m near the breakwater. Photo 2 shows the unloading area inside the south breakwater, built using boulders, facing the tip of the south breakwater. A number of fishing boats were moored inside the port, and Photo 3 shows the unloading area where a gentle concrete slope was constructed, and many people were actively working to unload fishes from fishing boats, as shown in Photos 3, 4 and 5. Although the mechanization level for the manpower-dependent fuel loading of the fishing boats or the unloading of fishes was low compared with the situation in Japan, many people actively worked, which is reminiscent of the past scenery of fishing ports in Japan. Thus, Pengambengan fishing port has really been utilized as a fishing port and as a base of unloading fishes in this area.

Photo 1. Southeast view from south breakwater of Pengambengan fishing port.

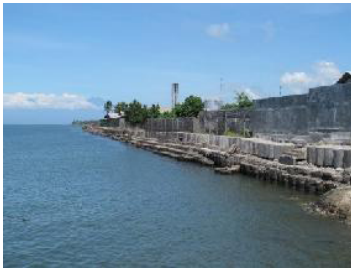
The beach had already been eroded north of the fishing port owing to the blockage of northward longshore sand transport by the fishing port breakwater (Uda et al., 2004). Photo 6 shows the eroded beach downcoast of the fishing port, taken from the base of the north breakwater, as shown in Fig. 2. The coastline was completely covered with the concrete seawall with no foreshore in front of the seawall. At site No. 7 located 1.3 km northwest of the north breakwater, the seawall collapsed owing to severe beach erosion, and the debris of the destroyed seawall extended straight under the sea surface, as shown in Photo 7. Moreover, at site No. 8 located 1 km north of site No. 7, although a natural sandy beach with tropical vegetation, such as palm trees, inland remained, as shown in Photo 8, the beach has been severely eroded, and many roots of palm trees were left on the shoreline, which is evidence of successive shoreline recession. Furthermore, behind the shoreline, a scarp was formed in front of houses and coastal vegetation died out while forming lumps of earth.

Photo 6. Coastline protected by seawall north of fishing port.

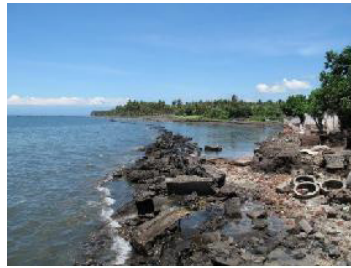
Photo 7. Collapsed seawall due to erosion north of fishing port.

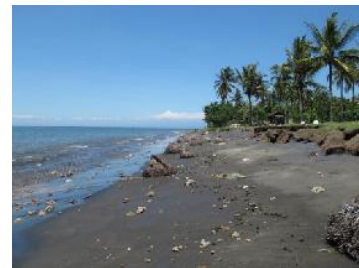
Photo 8. Scarp erosion of natural coast 1.0 km north of site No. 7.

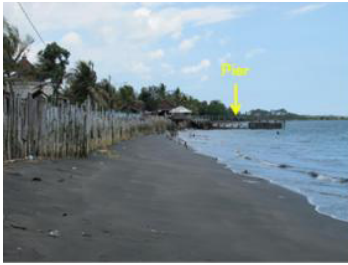
Downcoast of the slender sand bar, the beach has been severely eroded, and wooden fences have been constructed as a measure against beach erosion. Photo 9 shows the beach condition immediately downcoast of the pier, as shown by an arrow in Fig. 5. Wooden fences have been continuously constructed in this area as a measure against erosion, as shown in Photo 10, facing northwest on top of the pier. Two rows of wooden fences have been constructed with gravel in between to prevent further beach erosion. However, part of these wooden fences collapsed owing to the wave action. Photo 11 shows the eroded coastline looking towards the pier from site No. 11. As a result of the severe erosion, isolated roots of palm trees were observed. Further downcoast, a seawall made of circular concrete piles extended, as shown in Photo 12. However, on the downdrift side of the seawall, land was eroded up to the asphalt road, forming a scarp despite the installation of wooden fences, as shown in Photo 13. Photo 14 shows the northwest end of the wooden fence, and the entire coastal road was eroded, forming a scarp of 2 m height, and sand bags were placed as an urgent measure. Also, a tree isolated by the successive erosion can be seen. Photo 15 shows the two rows of wooden fences to protect houses against erosion on the north side, but they seemed to be ineffective. However, at site No. 16 located at the north end of the study area, a river that meandered in the northwest flows into the sea with the development of a large river mouth bar, and thus a wide foreshore was left showing accretion, as shown in Photo 16. Thus, beach erosion ceased at the river mouth 1.5 km northwest of the tip of the large-scale sand spit.

Photo 9. Pier extended at a location shown by an arrow in Fig. 5.

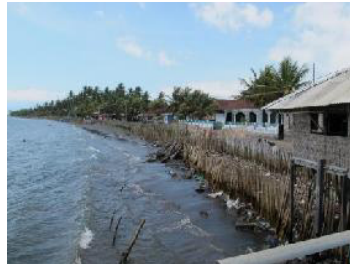
Photo 10. Northwest view from top of pier. Owing to the downcoast erosion, a number of wooden fences were constructed.

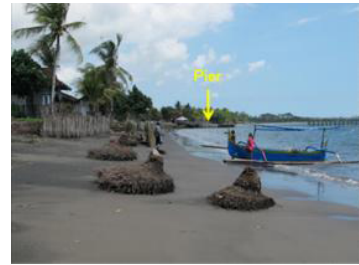
Photo 11. View of the pier from downcoast location.

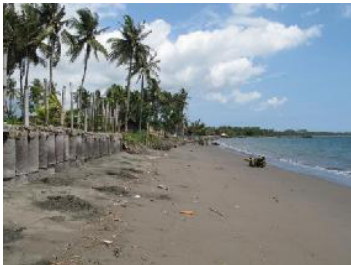
Photo 12. Seawall made of concrete piles.

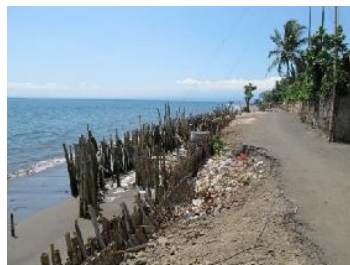
Photo 13. Eroded road that was protected against beach erosion by many wooden fences.

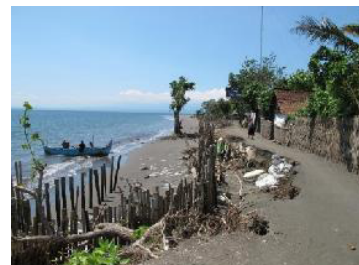
Photo 14. Scarp of 2 m height formed at northwest end of wooden fences.

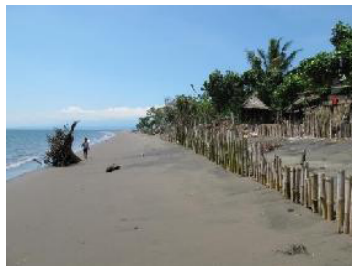
Photo 15. Two rows of wooden fences protecting houses.

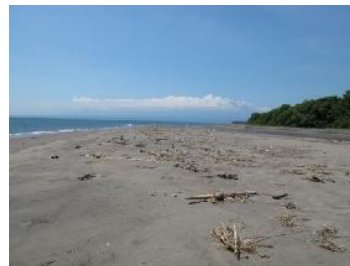
Photo 16. Large amount of sand deposited at river mouth.
